EXECUTIVE SUMMARY

Photographs	Observations and Recommendations

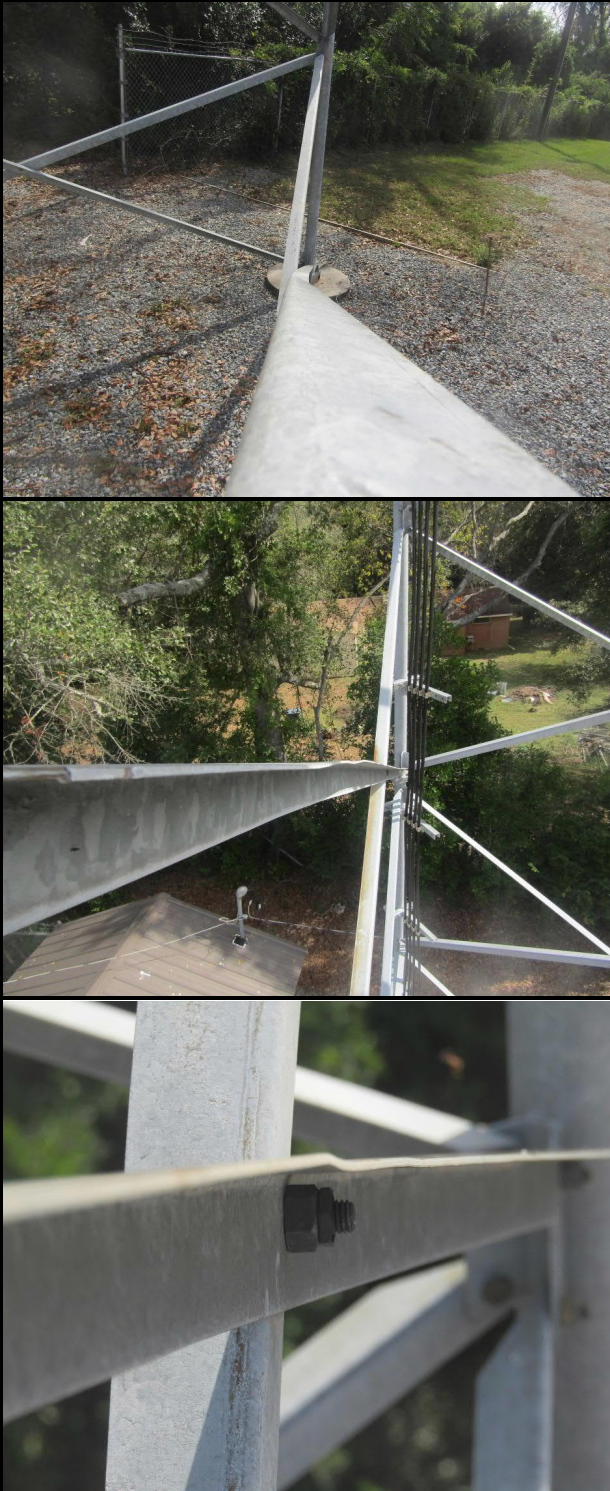
<p><u>A.1. Damaged members (legs and bracing)</u></p> <p>Observation: Bent bracing members were observed at the following locations:</p> <ul style="list-style-type: none">• 3-ft – BC face (L2.5"x2.5"x0.1875")• 23-ft – BC face (L2"x2"x0.125")• 23-ft – CA face (L2"x2"x0.125")• 50-ft – BC face (L2"x2"x0.125") <p>Recommendation: A structural engineer licensed in the state of GA should review to determine if a repair is required.</p>

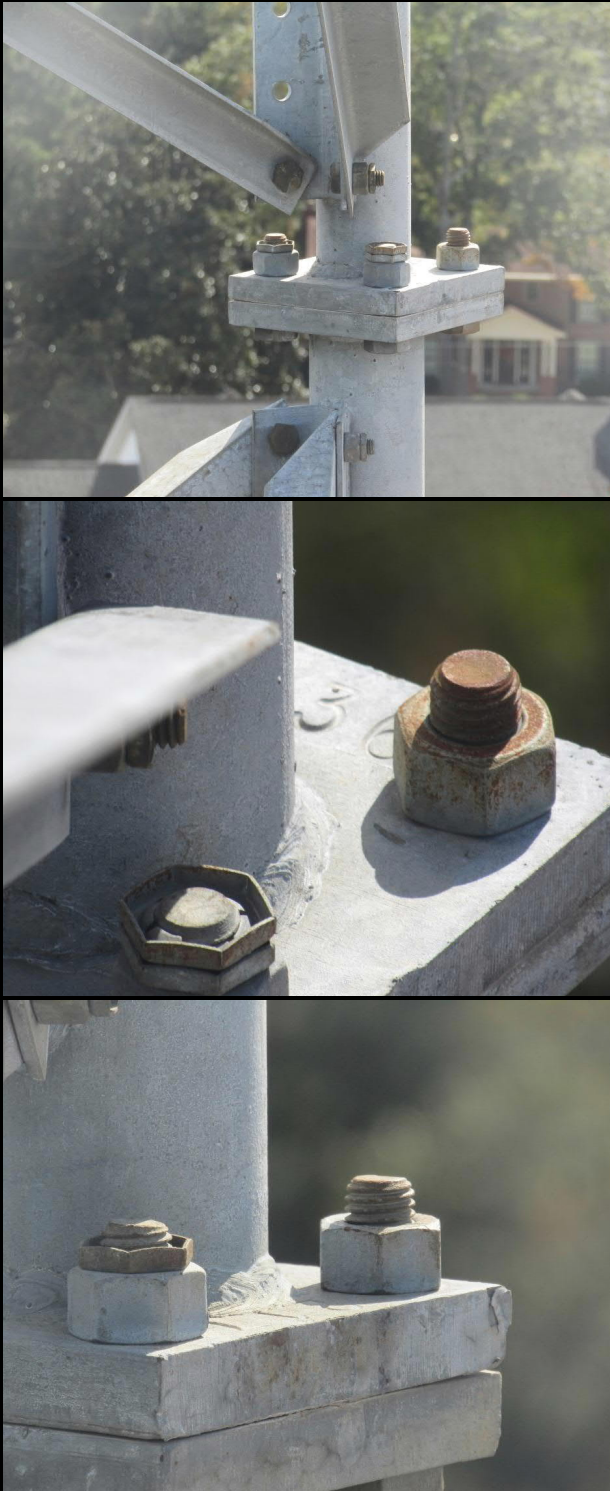
The first photograph shows a close-up of a tower joint with several bolts. The second photograph shows a close-up of a bolt and nut on a flange, with a nut locking device missing. The third photograph shows a close-up of two bolts on a flange, with one nut locking device missing.	<p><u>A.4. Loose and/or missing bolts and/or nut locking devices</u></p> <p>Observation: Missing nut locking devices were observed at the following locations:</p> <ul style="list-style-type: none">• 60-ft – B leg flange• 80-ft – B leg flange <p>Recommendation: Install a pal nut on the flange bolt or install a monitor line on the nut.</p>

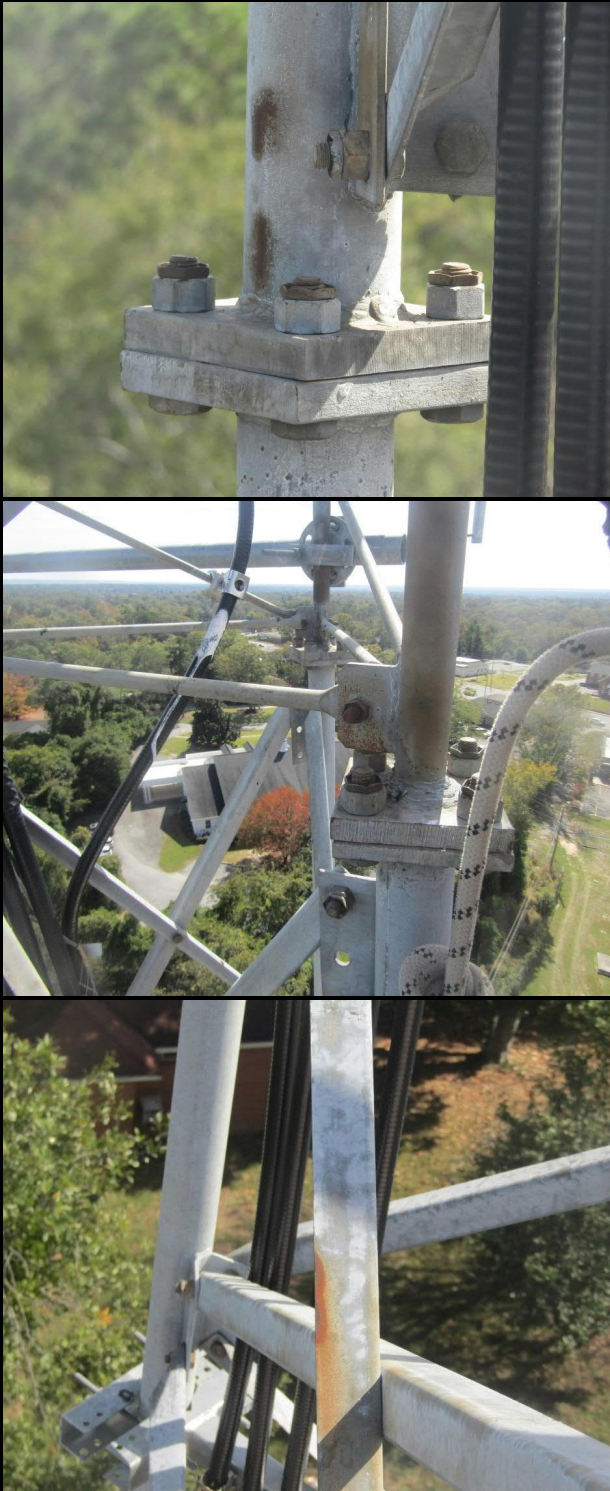
<p><u>B.2. Rust and/or corrosion condition including mounts and accessories</u></p> <p>Observation: Corrosion was observed at the following locations:</p> <ul style="list-style-type: none">• A leg at 80-ft• C leg gusset plate at 100-ft• CA face diagonal members from 5-ft to 100-ft• BC face diagonal at 124.5-ft <p>Recommendation: Thoroughly clean all areas of corrosion and apply two coats of a brush-on cold galvanizing compound containing at least 95% zinc.</p>

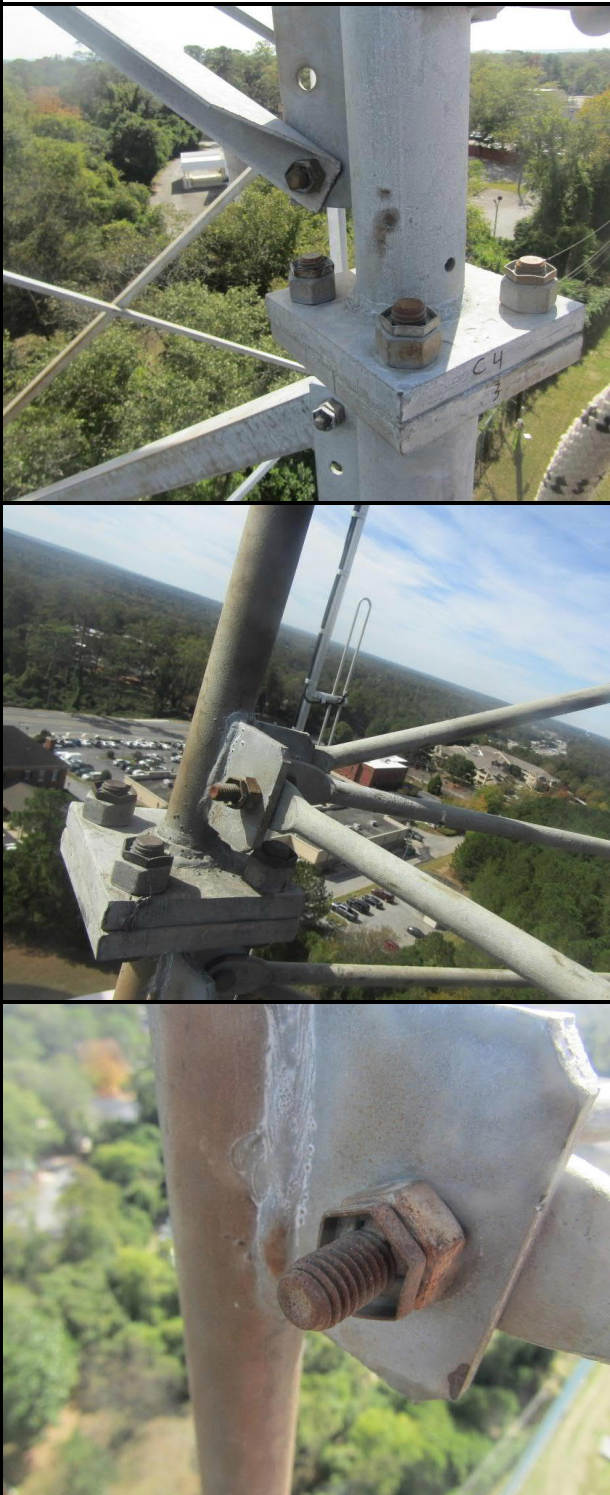
Photographs	Observations and Recommendations

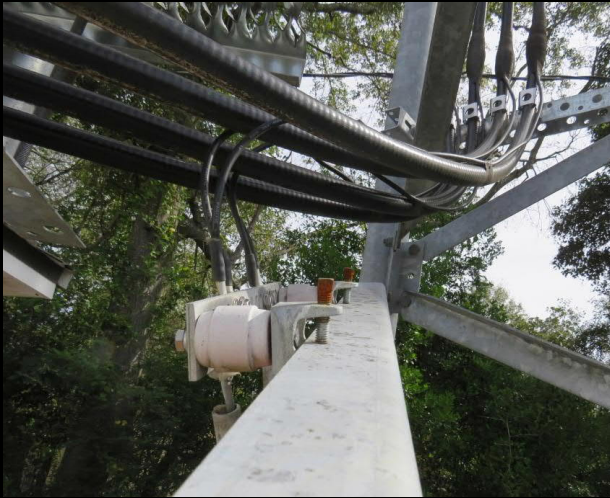
<p><u>D.2. Corrosion</u></p> <p>Observation: Corrosion was observed on ground bar connection hardware at the tower base.</p> <p>Recommendation: Thoroughly clean all areas of corrosion and apply two brush coats of a cold galvanizing compound containing at least 95% zinc. If during this process any section loss is observed, replace the hardware with one of equal size and grade.</p>

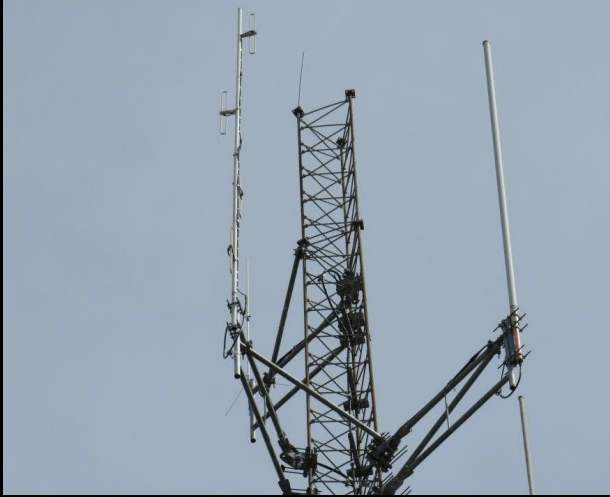
<p><u>D.3. Lightning protection (secured to structure)</u></p> <p>Observation: The lightning rod is bent.</p> <p>Recommendation: No action is required.</p>
