**ADDENDUM # 3**

Re: INVITATION FOR BIDS: 25-052-LH, Developer for Hotel and Convention Center at 108 First Street  
(former hotel site)

**Re:** Construction Materials Testing/ Special Inspections (**Compaction Testing**)  
108 First Street  
Macon, Georgia  
Terracon Proposal Number: HN251056

Terracon Consultants, Inc. (Terracon) is pleased to present this final package for Construction Materials Testing /Special Inspection during the fill placement and compaction testing at the 108 First Street project located in Macon Georgia.

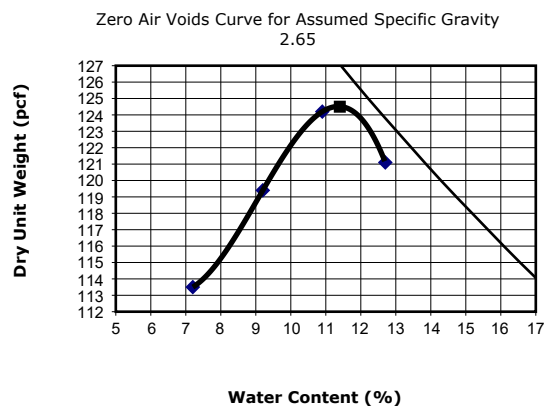
# LABORATORY COMPACTION CHARACTERISTICS OF SOIL REPORT

**Test Procedure:** ASTM D698  
**Test Method:** Method A  
**Sample Preparation:** Dry  
**Rammer Type:** Manual  
**Maximum Dry Unit Weight (pcf):** 124.5  
**Optimum Water Content (%):** 11.4

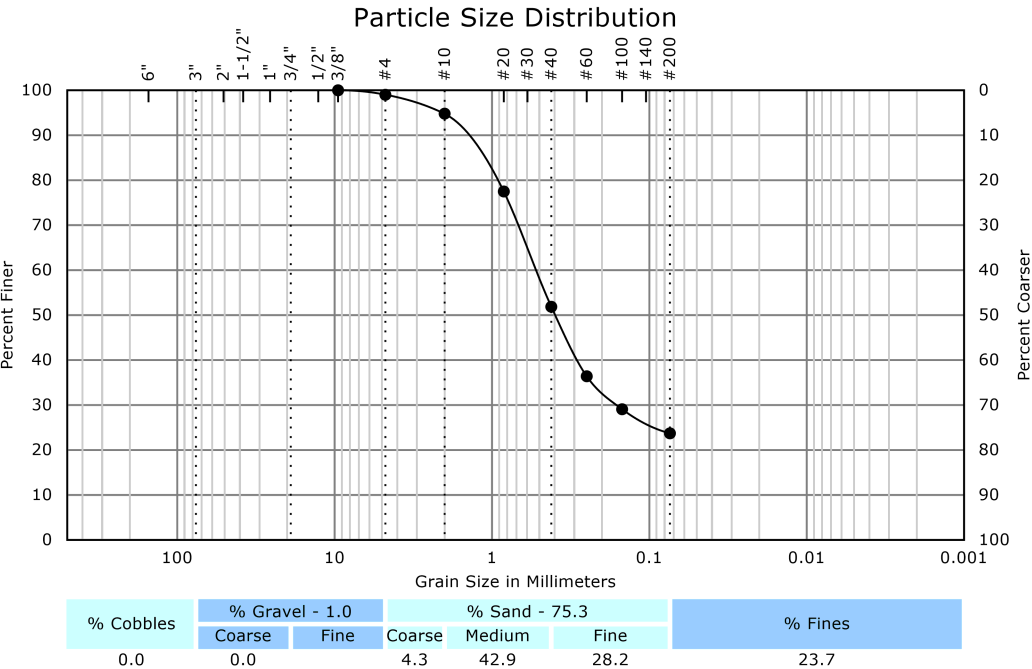
PARTICLE SIZE DISTRIBUTION REPORT

| * | $D_{60} = 0.53$ | $D_{30} = 0.16$ | $D_{10} =$ | $C_c =$ | $C_u =$ | FM = |

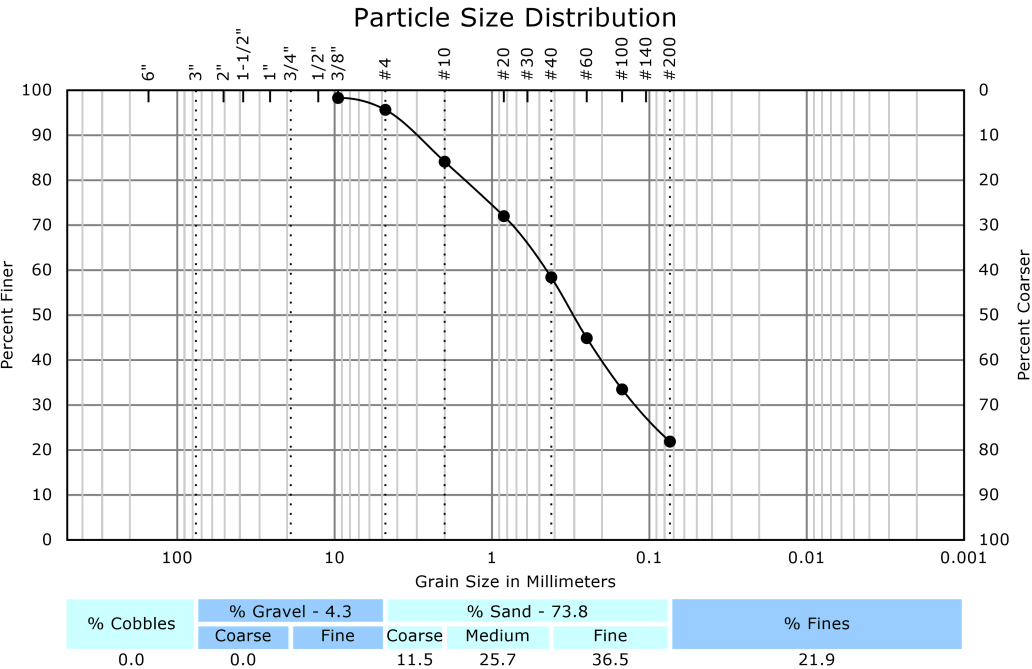
| * | D <sub>60</sub> = 0.45 | D <sub>30</sub> = 0.12 | D <sub>10</sub> = | C <sub>c</sub> = | C <sub>u</sub> = | FM = |

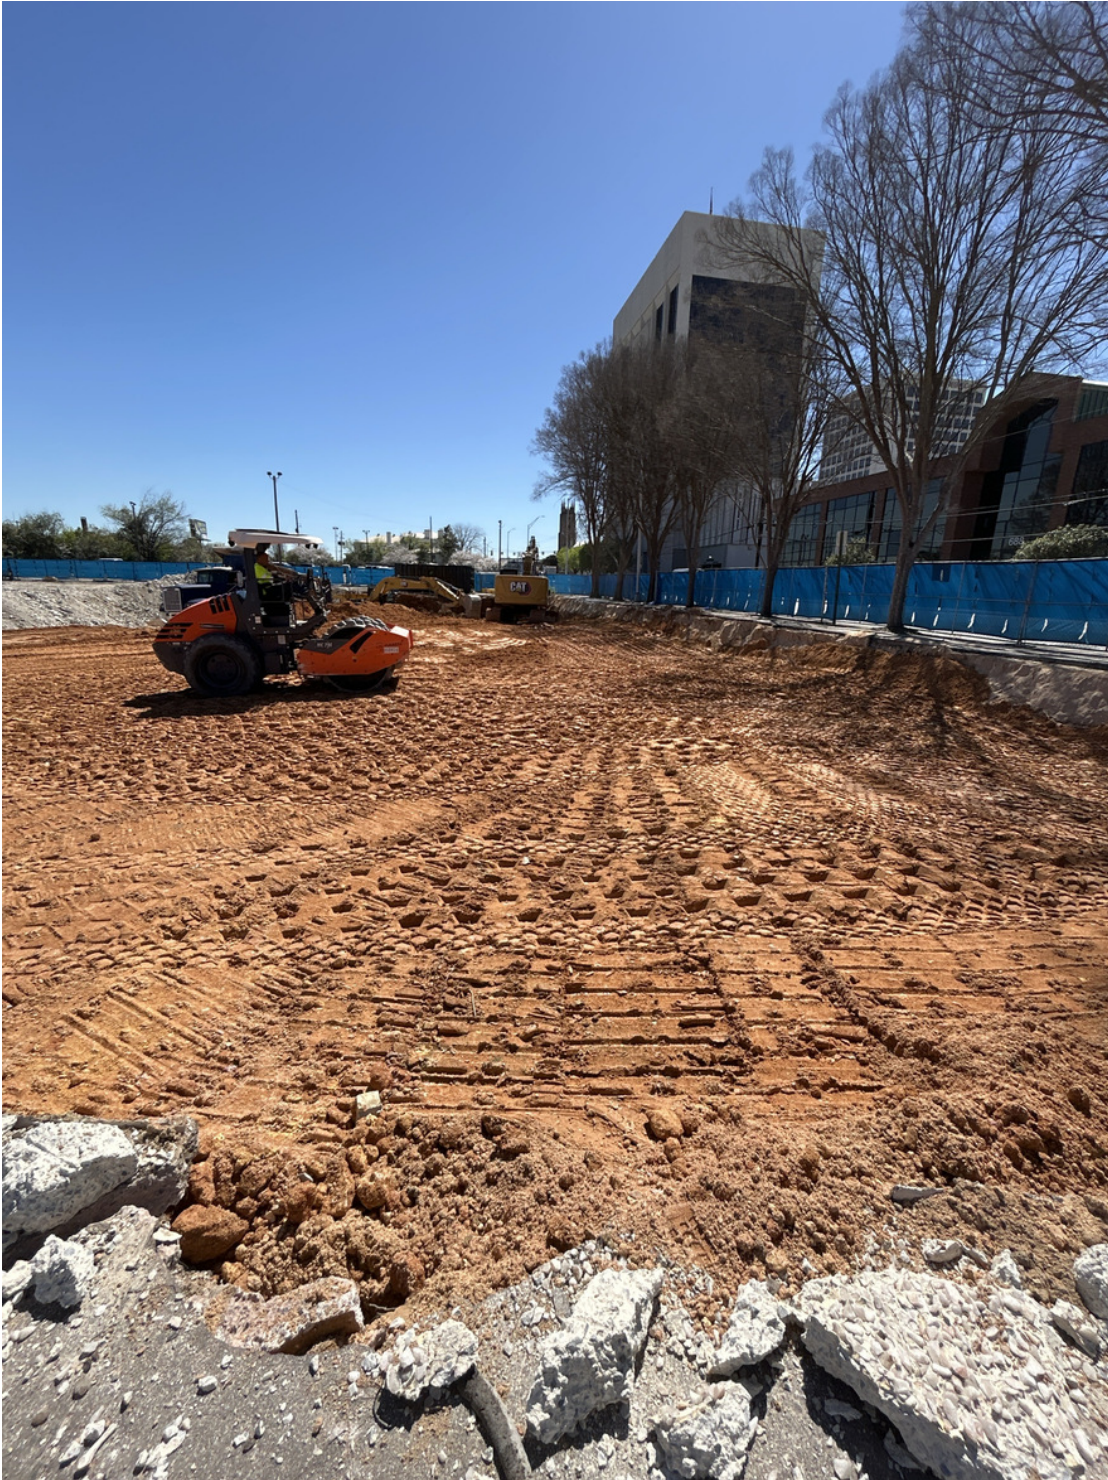
(P1) Fill at SW side of site

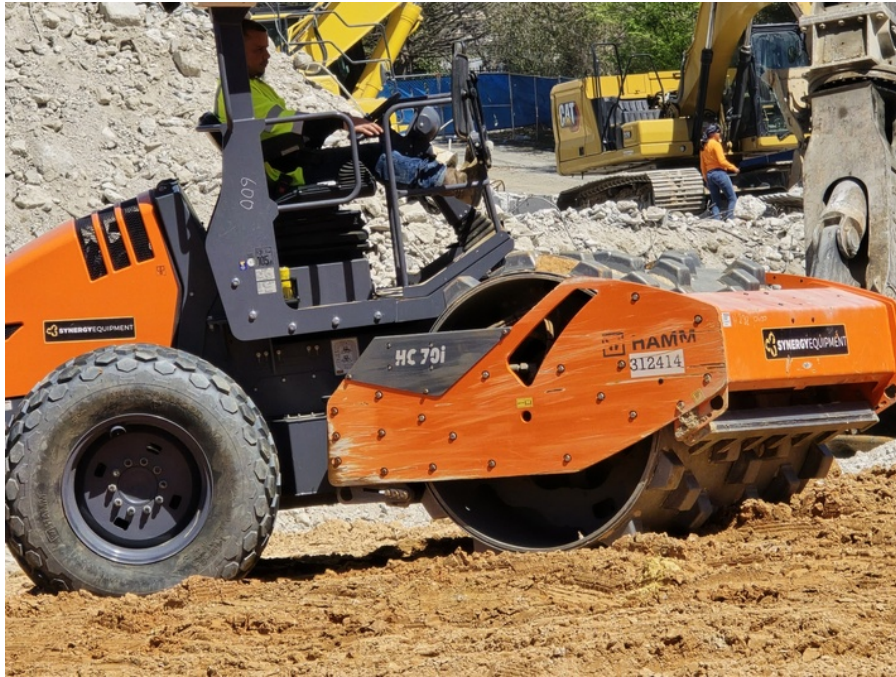
(P1) Roller used

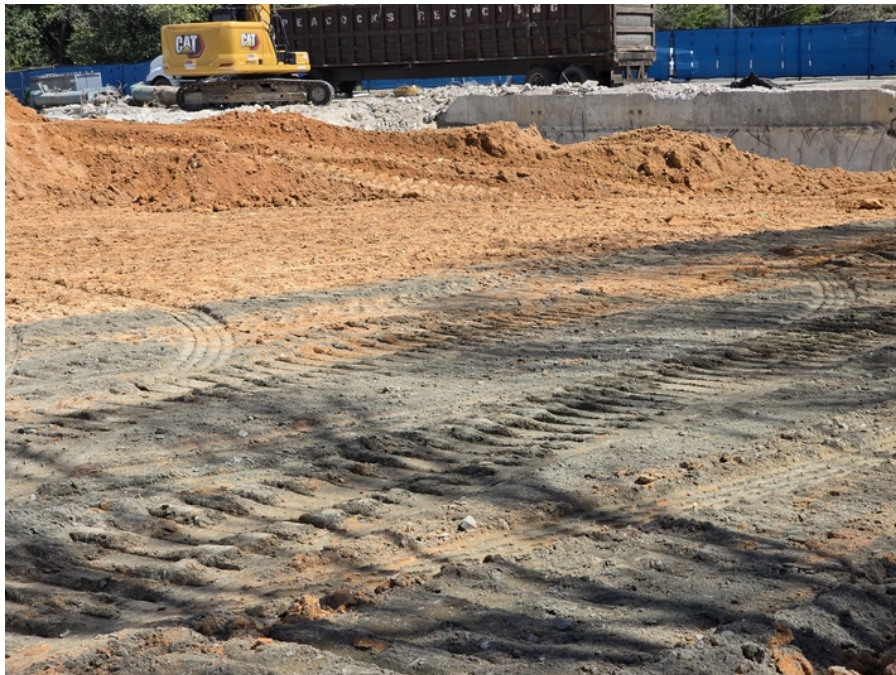
(P2) Area fill was placed

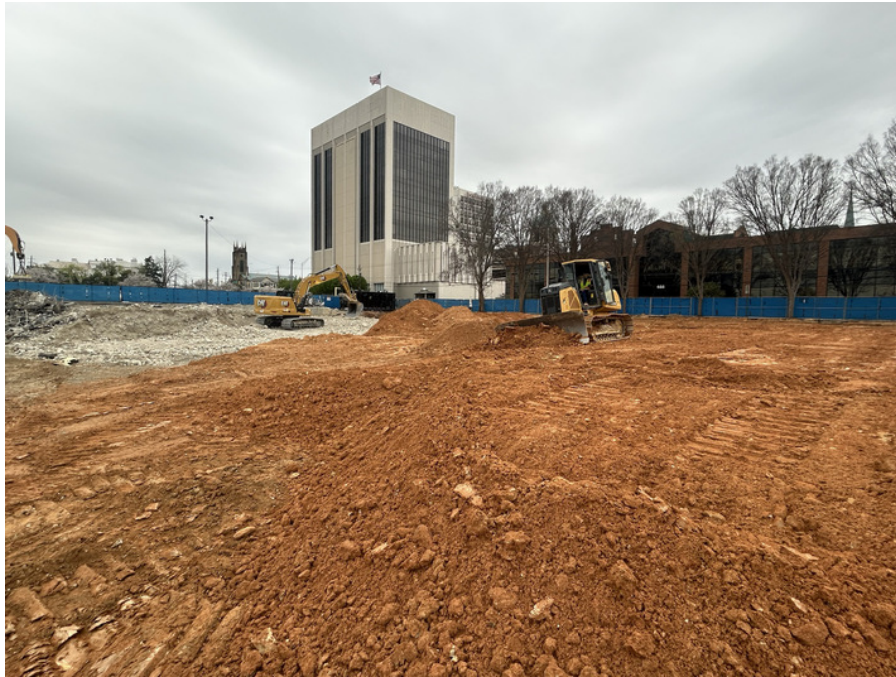
(P1) Placing fill.

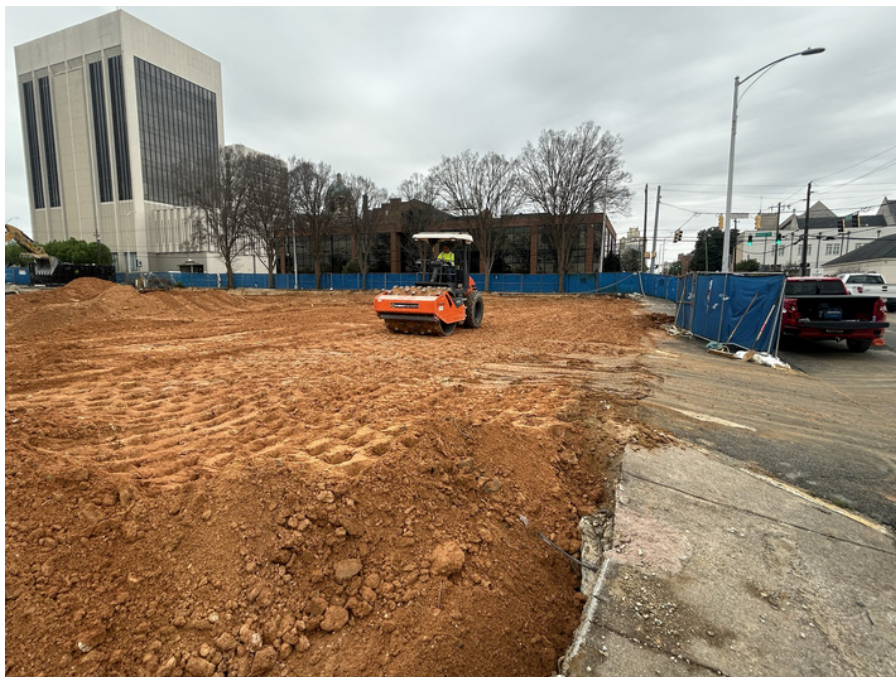
(P2) Compacting fill.

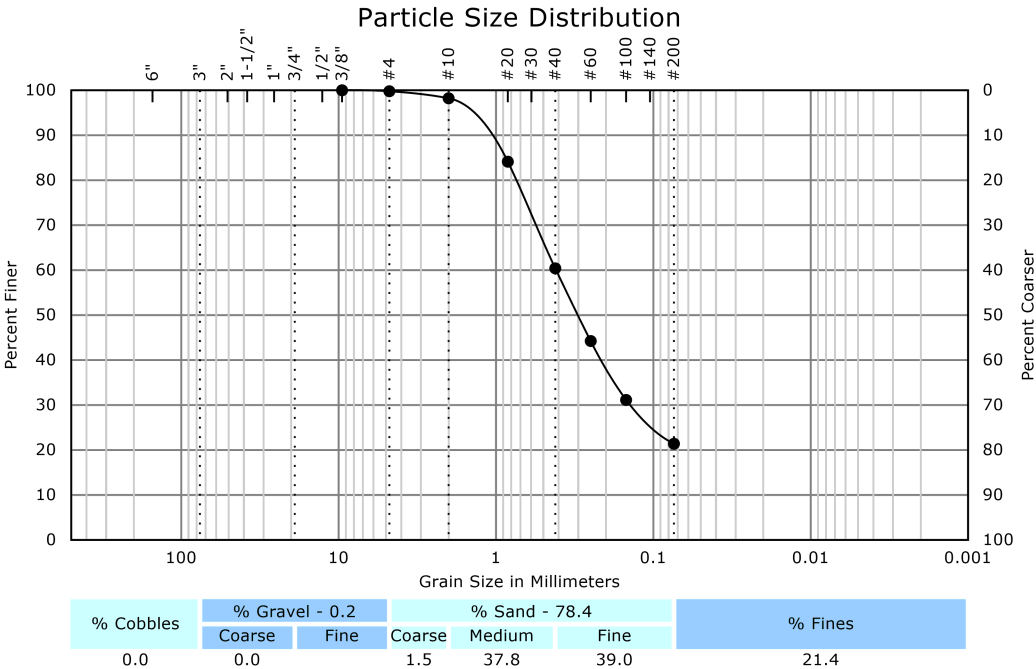
PARTICLE SIZE DISTRIBUTION REPORT

| * | $D_{60} = 0.41$ | $D_{30} = 0.14$ | $D_{10} =$ | $C_c =$ | $C_u =$ | FM = |
