Re: Hazardous Materials Survey Report
Terminal Building (Avionics Building)
Middle Georgia Regional Airport
Macon, Georgia
Terracon Project No. HN225215

Hazardous Materials Survey Report

Terminal Building (Avionics Building) ■ Macon, GA
June 27, 2023 ■ Terracon Project No. HN225215

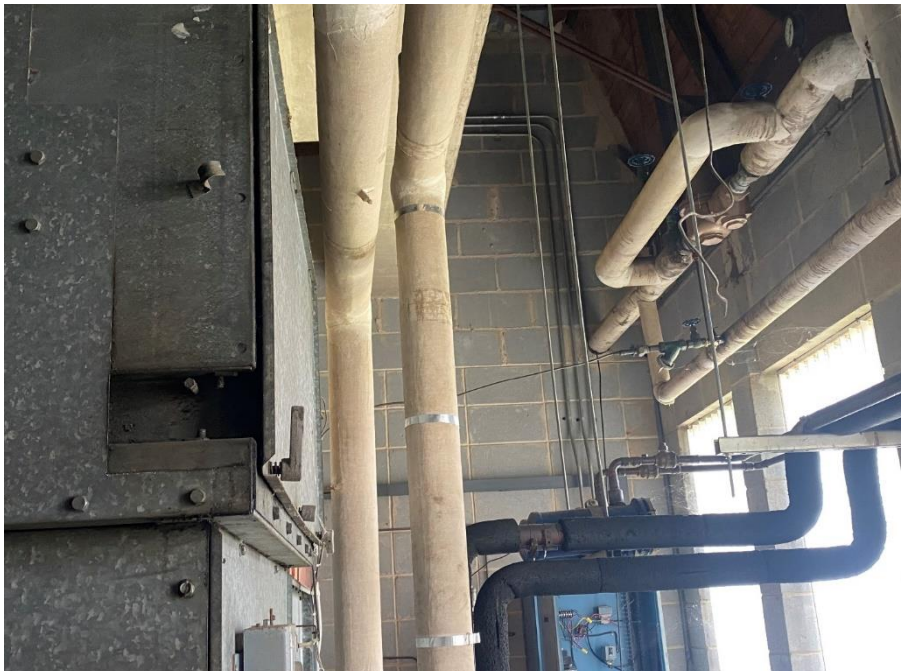
Site Photographs	Remarks
 	<p>General view of the asbestos containing black mastic on pipe elbows</p>

<p>General view of the Mechanical Rooms asbestos containing elbows and fittings</p>

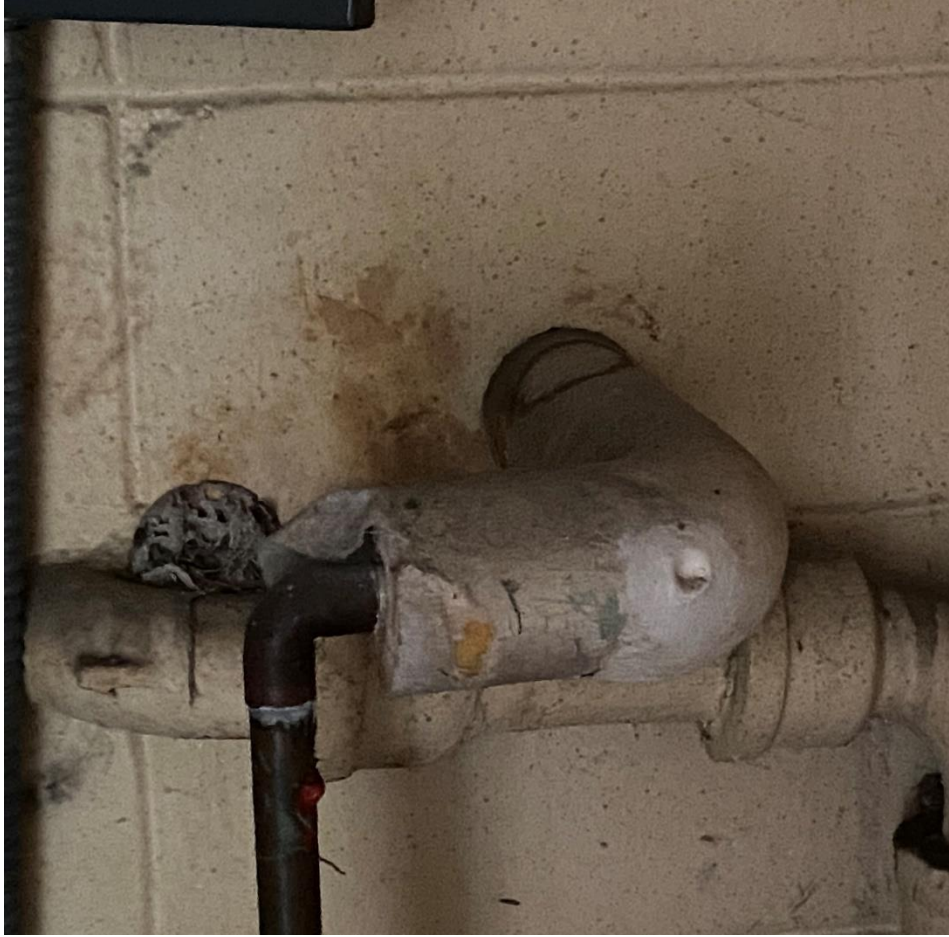
<p>General view of asbestos containing pipe elbow water heater closet</p>
