Re: Hazardous Materials Survey Report
Terminal Building (Lowe Aviation)
Middle Georgia Regional Airport
Macon, Georgia
Terracon Project No. HN225215

Hazardous Materials Survey Report

Terminal Building (Lowe's Aviation) ■ Macon, GA
June 27, 2023 ■ Terracon Project No. HN225215

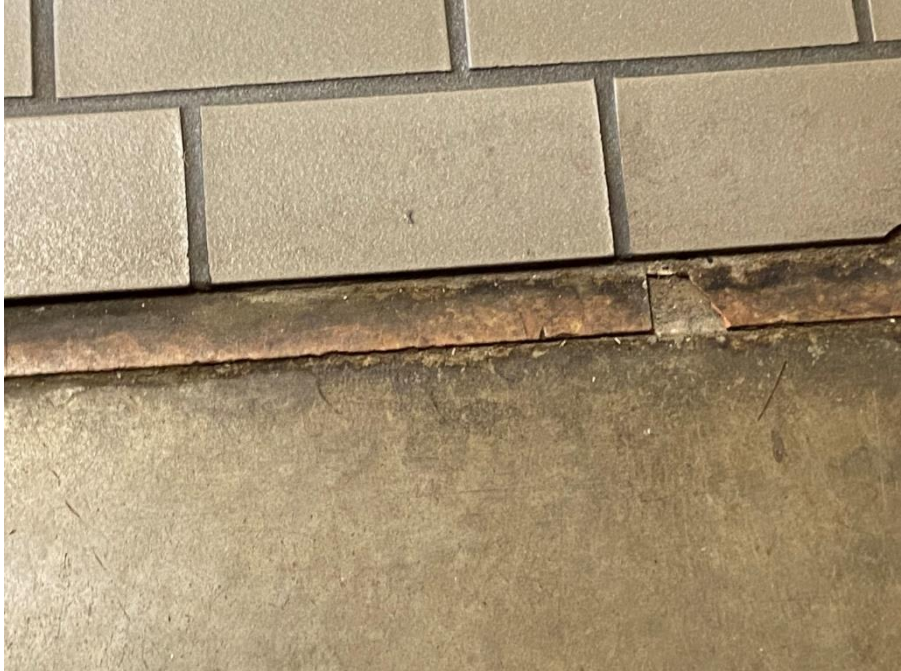
<p>General view of the asbestos containing floor tile (Black Mastic) under ceramic tile hallway.</p>

If additional but un-sampled suspect ACMs are revealed during renovation or demolition activities, the material(s) must be assumed to contain asbestos and treated as such unless sampled by an accredited inspector and laboratory analysis determines otherwise.

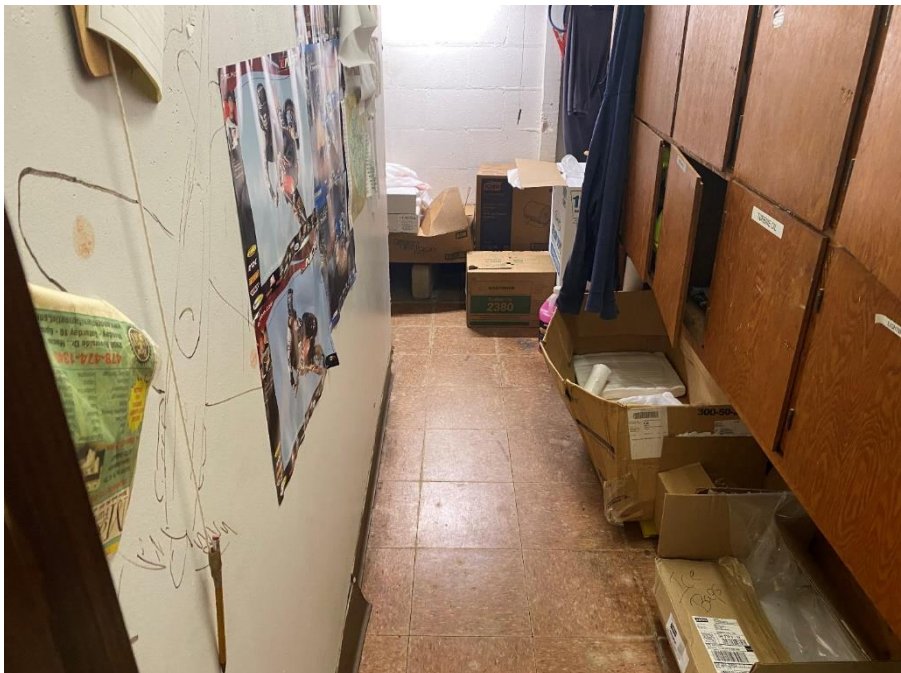
<p>General view of the asbestos containing floor tile (Black Mastic) in storage closet under stairway</p>
