Macon City Auditorium

DRAFT Program Scope Recommendations

February 7, 2020

MACON CITY AUDITORIUM PROJECT SCOPE RECOMMENDATIONS

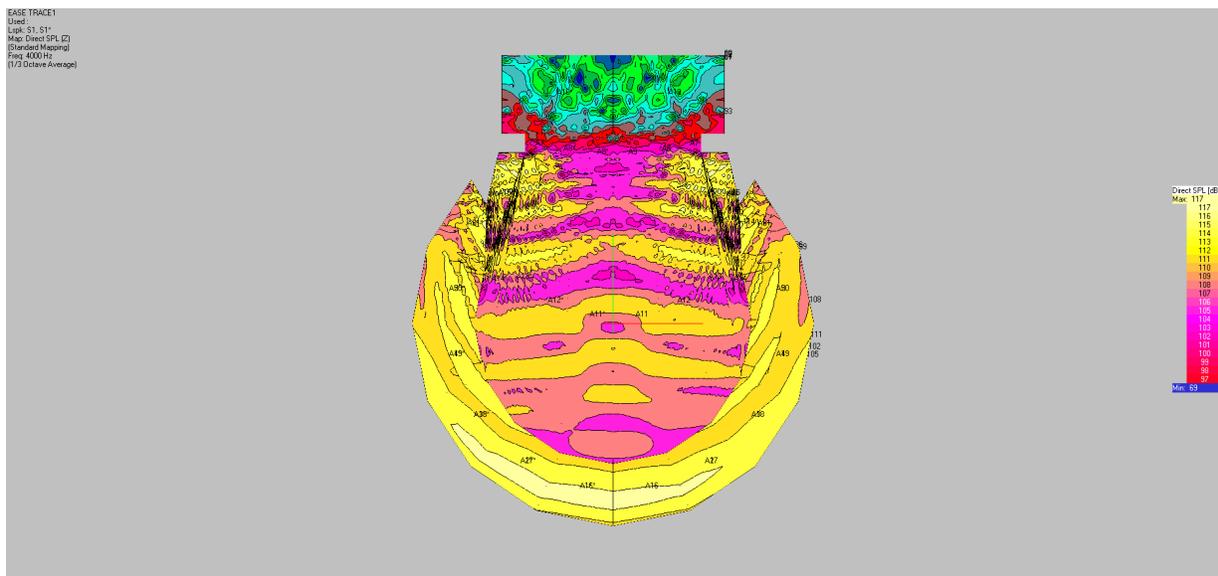
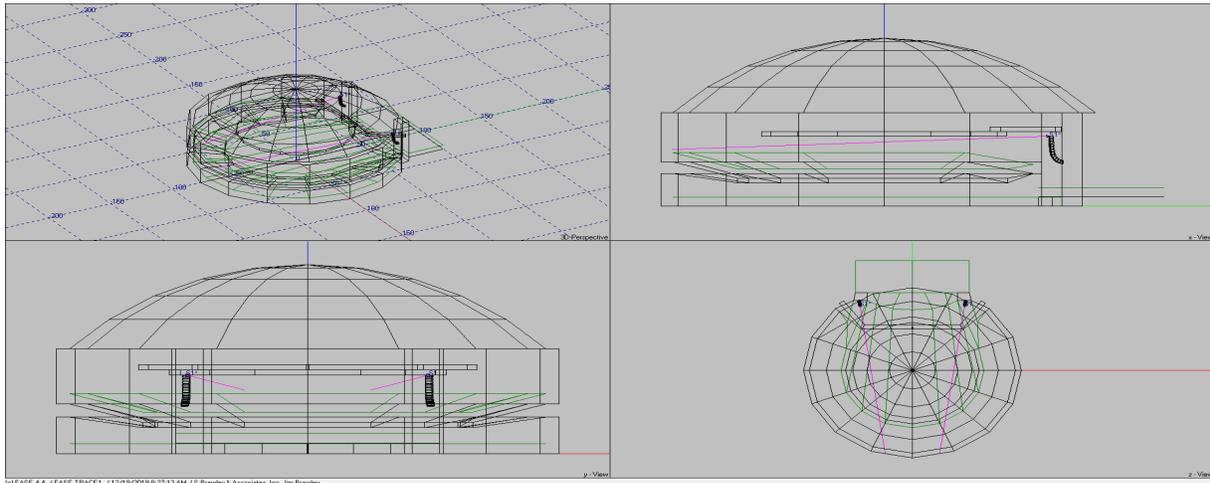
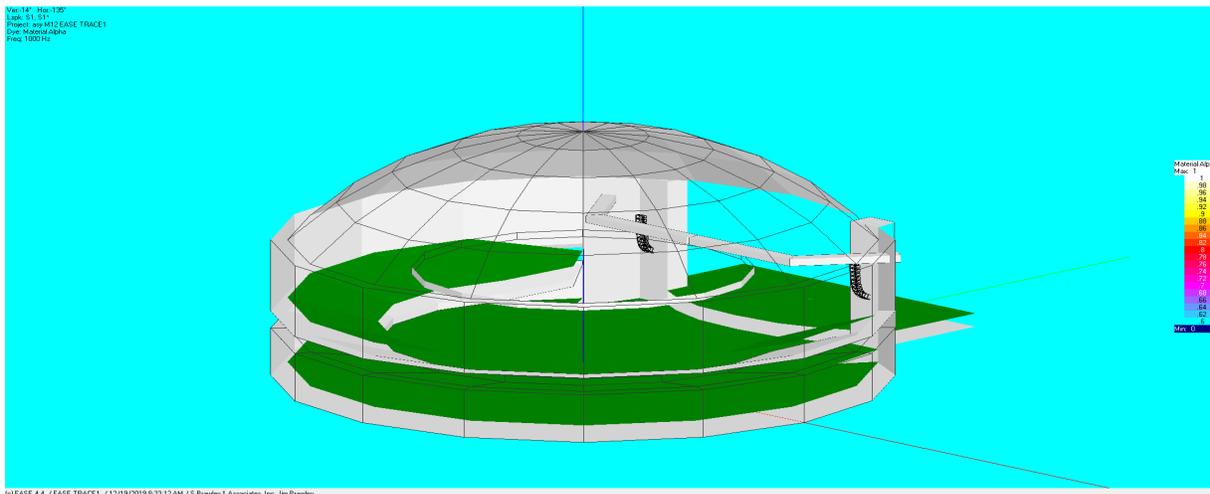
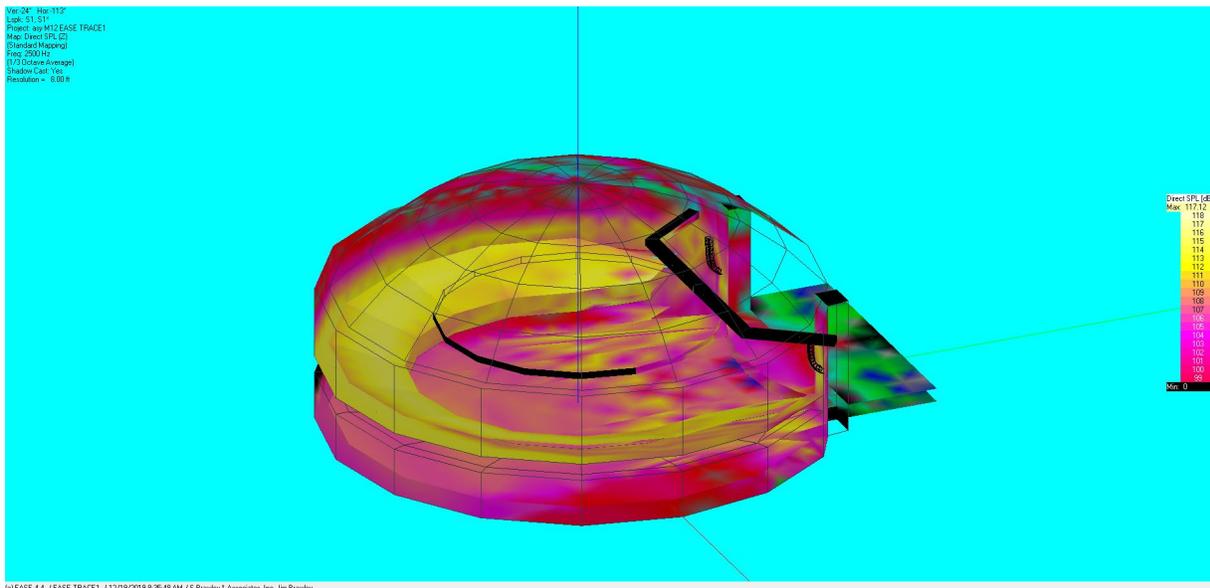
In the below diagrams we have created an EASE simulation model for the auditorium, that shows the preliminary design locations for the "house" PA and sound coverage of the room.

In some cases, the "House" PA system may not meet the technical requirements for a specific road show act. The plan for this situation will be to design designated rigging points above the stage left and right sides for road show PA rigging. There will also be an infrastructure of network patch lines designated specifically for the road show technical team to connect audio gear from the FOH mix position to the stage. This will reduce the need to free run excessive amounts of cabling around the auditorium from the stage to the FOH mix position, which is the current process.
